TEST REPORT

Report Ref. No.	13EMC-RT-0855	
Date of issue	2013-06-21	
Applicant Name Address 	Samsung Techwin Co., Ltd. #42 Seongju-Dong, Changwon-Shi, Kyungsangnam-Do, Korea	
Factory ○ Name ○ Address	TIANJIN SAMSUNG TECHWIN OPTO-ELECTRONIC CO., LTD No.11 Weiliu Road. Micro-Electronic Industrial Park Jingang Road Tianjin 300385, China	
Equipment○ Product○ Model	Network Camera SNV-6012M* (* is N or P)	
Standard	IEC 62262 and IEC 60068-2-75	
Technician	Hyunwook, Song	
Approved	Jaekyu, Lee	7. k. la

Degree of protection provided by enclosure for external impacts IK10

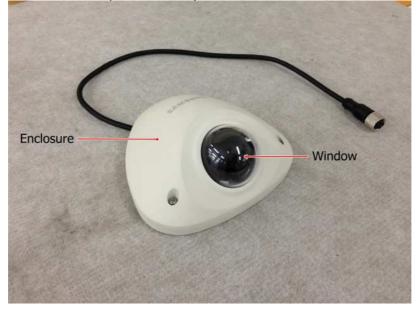
5. Drop Zones:

The areas that were focused upon for this impact test are as follows:

Drop Zone: Enclosure			
Drop #	Orientation / Results	Pass / Fail	
Drop 1	Normal to surface of enclosure. Scuff	Pass	
Drop 2	Normal to surface of enclosure, about 90° circumferentially from previous drop. Scuff	Pass	
Drop 3	Normal to surface of enclosure, about 90° circumferentially from previous drop. Open	Pass	
Drop 4	Normal to surface of enclosure, about 90° circumferentially from previous drop. Broken (sun visor)	Pass	
Drop 5	Normal to surface of enclosure, about 90° circumferentially from previous drop. Open	Pass

Drop Zone: Window			
Drop #	Orientation / Results	Pass / Fail	
Drop 1	Vertical drop onto center of Window. Scuff	Pass	
Drop 2	Normal to surface of side Window. Scuff	Pass	
Drop 3	Normal to surface of side Window, about 90° circumferentially from previous drop. Scuff	Pass	
Drop 4	Normal to surface of side Window, about 90° circumferentially from previous drop. Scuff	Pass	
Drop 5	Normal to surface of side Window, about 90° circumferentially from previous drop. Scuff	Pass
